**Flood Control Project Maintenance  
Levee Inspections**

## Maintenance Issue Types Only, Levee Inspection Report By Mile - Spring 2017

### Sacramento Maintenance Yard Sacramento Bypass

Waterway	Bank	Unit Miles	Inspection Start/End	Inspector
Unit No. 01 Sacramento Bypass or North Levee	Right	1.74	04/18/2017 04/18/2017	Zach Jojola

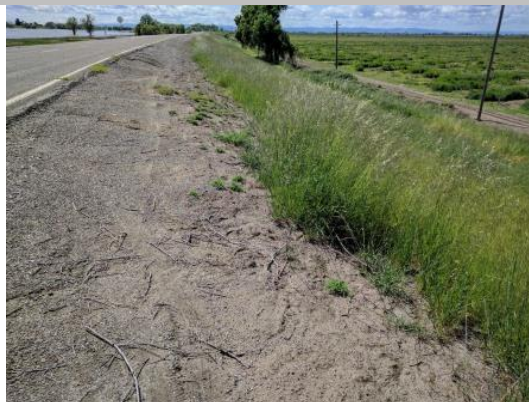
Photo 1 of 1 : SP\_2017\_ST0008\_284\_9\_20170419\_00014.jpg

LM Start	0.05	Rating **	U	Issue No.	9
LM End	1.73	Issue Type +	Ma	Location *	LS
Category	Earthen Levee		GPS Latitude/Longitude		
			Start	End	
Item	Vegetation		38.606917 °	38.599516 °	
			-121.560718 °	-121.590145 °	
DWR ID	DWR_ST0008_01_s_2017_9				
Comment Code					
V1 : Control annual grass and weeds on the levee slopes and easements.					
Inspector Comment

Tall grass on the landside slope, blocking visibility. Spring 2017.

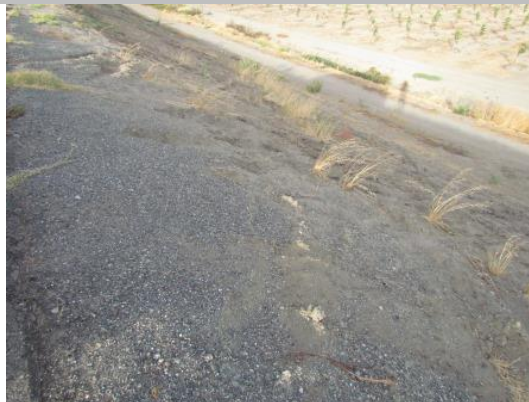
Photo 1 of 1 : SP\_2017\_ST0008\_284\_6\_20170320\_00001.jpg

LM Start	0.08	Rating **	M	Issue No.	6
LM End	0.08	Issue Type +	Ma	Location *	LS
Category	Earthen Levee		GPS Latitude/Longitude		
			Start	End	
Item	Slope Stability		38.606622 °	38.606622 °	
			-121.561266 °	-121.561266 °	
DWR ID	DWR_ST0008_01_f_2016_6				
Comment Code					
S3 : Repair the levee slope damaged by vehicle traffic and prevent access where possible.					
Inspector Comment

Slope stability issue caused by vehicles. Fall 2016.

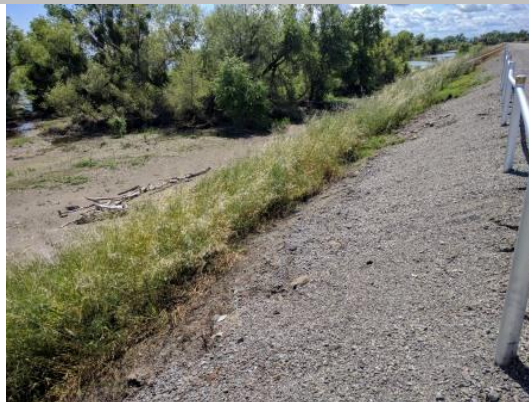
Photo 1 of 1 : SP\_2017\_ST0008\_284\_11\_20170419\_00015.jpg

LM Start	0.41	Rating **	U	Issue No.	11
LM End	1.73	Issue Type +	Ma	Location *	WS
Category	Earthen Levee			GPS Latitude/Longitude	
				Start	End
Item	Vegetation			38.605003 °	38.599516 °
				-121.566835 °	-121.590145 °
DWR ID	DWR_ST0008_01_s_2017_11				
Comment Code					
V1 : Control annual grass and weeds on the levee slopes and easements.					
Inspector Comment

Tall grass on waterside slope, blocking visibility. Spring 2017.

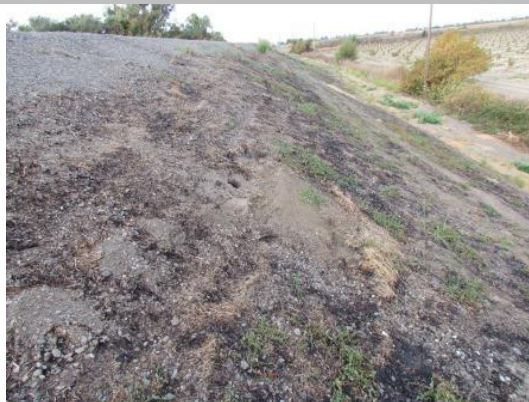
Photo 1 of 2 : SP\_2017\_ST0008\_284\_10\_20170320\_00003.jpg

LM Start	0.94	Rating **	A/W	Issue No.	10
LM End	0.94	Issue Type +	Ma	Location *	LS
Category	Earthen Levee			GPS Latitude/Longitude	
				Start	End
Item	Animal Control			38.602763 °	38.602763 °
				-121.576288 °	-121.576288 °
DWR ID	DWR_ST0008_01_f_2015_10				
Comment Code					
A3 : No rodents visible, but rodent burrows visible; need to backfill and compact or grout burrows.					
Inspector Comment

An updated view of the rodent holes on LS slope. Fall 2016.

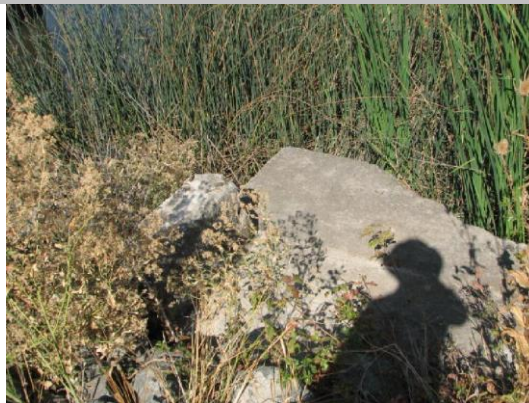
Photo 2 of 3 : UCIP\_SP\_2017\_44787\_20604.jpg

LM Start	1.09	Rating **	A/W	Issue No.	16 (cont)
LM End	1.09	Issue Type +	Ma	Location *	LS
Category	Supplemental			GPS Latitude/Longitude	
				Start	End
Item	DWR UCIP LMA Responsibility			38.602169 °	38.602169 °
				-121.579000 °	-121.579000 °
DWR ID					
Comment Code					
Inspector Comment					
FS_ID:44787 DS_ID:19076 EP_NO: N/A Repair Type: No Action Needed Crossing Status: Found UCIP Comments: A concrete saddle found on slough/drainage. No pump was found on LS and no structure/pipe found on WS. FIELD_STRUCT_DESC: An abandoned grouted 36-inch CM pipe. Remainig of concrete structure found on LS.O&M Manual Sac 122.1, August 1955, Revision Year 2011. FS Date: 4/28/2015 2:44:05 PM

Landside view: remaining of concrete structure

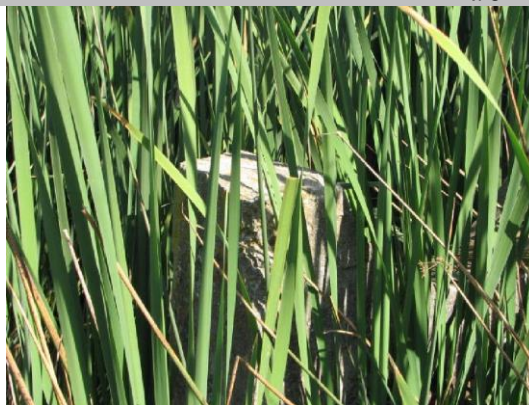
Photo 3 of 3 : UCIP\_SP\_2017\_44787\_20606.jpg

Landside view: remaining of concrete structure on drainage/slough

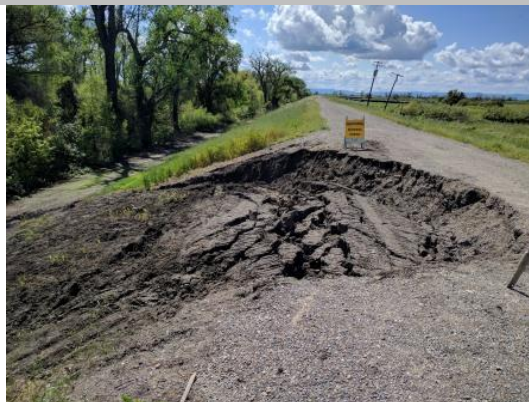
Photo 1 of 1 : SP\_2017\_ST0008\_284\_12\_20170419\_00016.jpg

LM Start	1.22	Rating **	M	Issue No.	12
LM End	1.22	Issue Type +	Ma	Location *	WS
Category	Earthen Levee			GPS Latitude/Longitude	
				Start	End
Item	Slope Stability			38.601606 °	38.601606 °
				-121.581240 °	-121.581240 °
DWR ID	DWR_ST0008_01_s_2017_12				
Comment Code					
S1 : Repair slope instability.					
Inspector Comment					
Large sloughing site on waterside levee slope and crown.

View of sloughing on waterside levee slope and crown. Spring 2017.

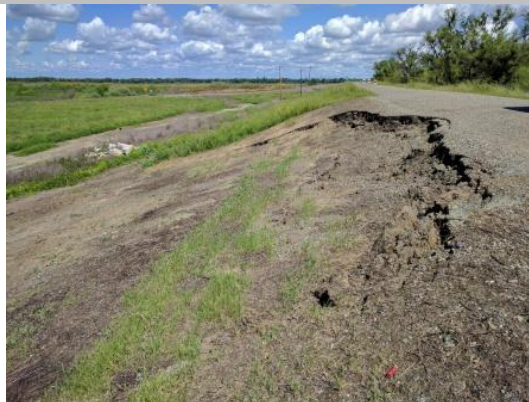
Photo 1 of 1 : SP\_2017\_ST0008\_284\_13\_20170419\_00017.jpg

LM Start	1.28	Rating **	M	Issue No.	13
LM End	1.28	Issue Type +	Ma	Location *	LS
Category	Earthen Levee			GPS Latitude/Longitude	
				Start	End
Item	Slope Stability			38.601325 °	38.601325 °
				-121.582177 °	-121.582177 °
DWR ID	DWR_ST0008_01_s_2017_13				
Comment Code					
S1 : Repair slope instability.					
Inspector Comment					
Sloughing on landside levee slope.

View of sloughing on landside levee slope. Spring 2017.

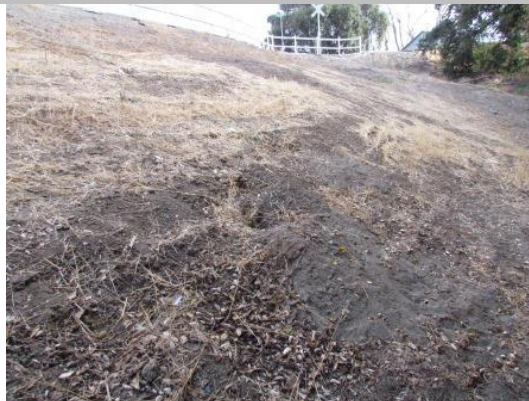
Photo 1 of 1 : SP\_2017\_ST0008\_285\_2\_20170320\_00001.jpg

LM Start	0.03	Rating **	A/W	Issue No.	2
LM End	0.03	Issue Type +	Ma	Location *	LS
Category	Earthen Levee			GPS Latitude/Longitude	
				Start	End
Item	Animal Control			38.602613 °	38.602613 °
				-121.556021 °	-121.556021 °
DWR ID	DWR_ST0008_02_s_2016_2				
Comment Code					
A3 : No rodents visible, but rodent burrows visible; need to backfill and compact or grout burrows.					
Inspector Comment

View of rodent holes on LS slope of the levee near entry gate. Fall 2016..

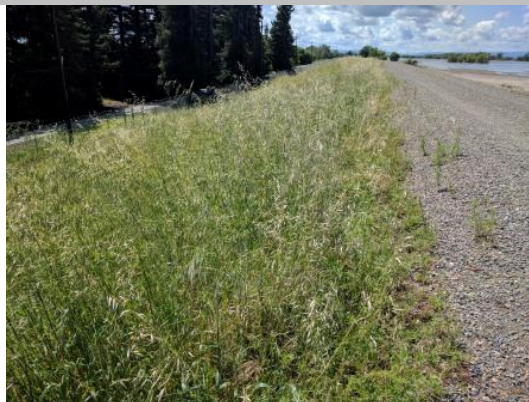
Photo 1 of 1 : SP\_2017\_ST0008\_285\_1\_20170419\_00007.jpg

LM Start	0.03	Rating **	U	Issue No.	1
LM End	1.77	Issue Type +	Ma	Location *	LS
Category	Earthen Levee			GPS Latitude/Longitude	
				Start	End
Item	Vegetation			38.602607 °	38.594797 °
				-121.556077 °	-121.586479 °
DWR ID	DWR_ST0008_02_s_2017_1				
Comment Code					
V1 : Control annual grass and weeds on the levee slopes and easements.					
Inspector Comment

Tall grass on landside levee slope, blocking visibility. Spring 2017.

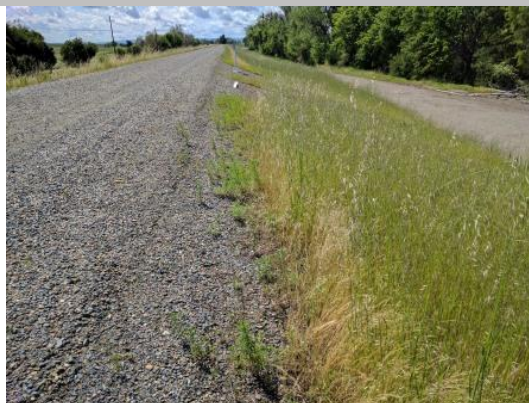
Photo 1 of 1 : SP\_2017\_ST0008\_285\_3\_20170419\_00008.jpg

LM Start	0.51	Rating **	U	Issue No.	3
LM End	1.14	Issue Type +	Ma	Location *	WS
Category	Earthen Levee			GPS Latitude/Longitude	
				Start	End
Item	Vegetation			38.600333 °	38.597757 °
				-121.564416 °	-121.575579 °
DWR ID	DWR_ST0008_02_s_2017_3				
Comment Code					
V1 : Control annual grass and weeds on the levee slopes and easements.					
Inspector Comment

Tall grass on waterside levee slope, blocking visibility. Spring 2017.

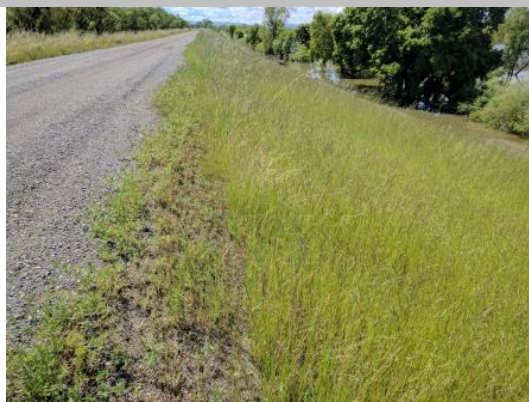
Photo 1 of 1 : SP\_2017\_ST0008\_285\_4\_20170424\_00011.jpg

LM Start	1.24	Rating **	U	Issue No.	4	
LM End	1.77	Issue Type +	Ma	Location *	WS	
Category	Earthen Levee			GPS Latitude/Longitude		
				Start	End	
Item	Vegetation			38.597328 °	38.594797 °	
				-121.577406 °	-121.586479 °	
DWR ID	DWR_ST0008_02_s_2017_4					
Comment Code						
V1 : Control annual grass and weeds on the levee slopes and easements.						
Inspector Comment

Tall grass on waterside levee slope, blocking visibility. Spring 2017.

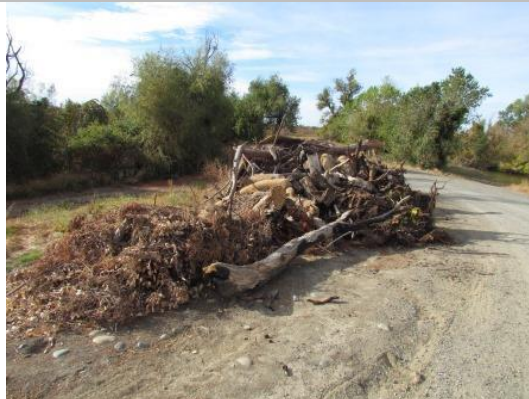
Photo 1 of 2 : SP\_2017\_ST0008\_285\_5\_20170320\_00002.jpg

LM Start	1.78	Rating **	M	Issue No.	5
LM End	1.78	Issue Type +	Ma	Location *	LS
Category	Earthen Levee			GPS Latitude/Longitude	
				Start	End
Item	Encroachments			38.594702 °	38.594702 °
				-121.586604 °	-121.586604 °
DWR ID	DWR_ST0008_02_s_2016_5				
Comment Code					
PR : Prunings					
Inspector Comment					
This is a seasonal pile but gets burned by the LMA each year.

More debris was added to the pile since the time of last inspection. Fall 2016.

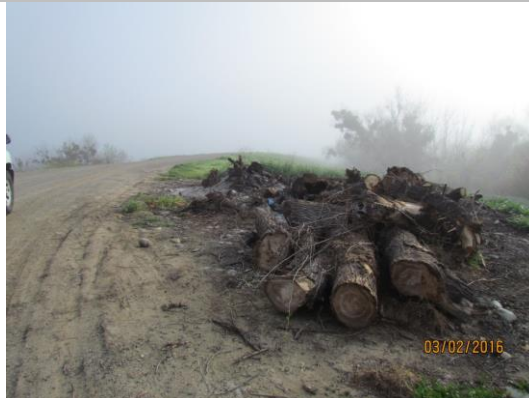
Photo 2 of 2 : SP\_2017\_ST0008\_285\_5\_20170320\_00003.jpg

View of the firewood on the landward side of the levee looking upstream. Spring 2016.
